Contract #: 04-0120F4Cty: SF/ALA Rte: 80 PM: 13.2/13.9File #: 69.28**WELDING INSPECTION REPORT****Resident Engineer:**Siegenthaler, Peter**Address:** 333 Burma Road**City:** Oakland, CA 94607**Report No:** WIR-022423**Date Inspected:** 05-Apr-2011**Project Name:** SAS Superstructure**OSM Arrival Time:** 700**Prime Contractor:** American Bridge/Fluor Enterprises, a JV**OSM Departure Time:** 1900**Contractor:** Zhenhua Port Machinery Company, Ltd (ZPMC), Changxing Island **Location:** Shanghai, China**CWI Name:** An Qing Xiang**CWI Present:** Yes No**Inspected CWI report:** Yes No N/A**Rod Oven in Use:** Yes No N/A**Electrode to specification:** Yes No N/A**Weld Procedures Followed:** Yes No N/A**Qualified Welders:** Yes No N/A**Verified Joint Fit-up:** Yes No N/A**Approved Drawings:** Yes No N/A**Approved WPS:** Yes No N/A**Delayed / Cancelled:** Yes No N/A**Bridge No:** 34-0006**Component:** OBG**Summary of Items Observed:**

WELDING INSPECTION REPORT

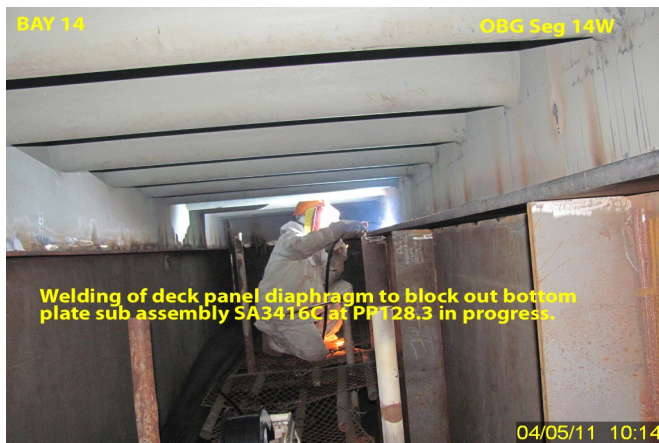
The Flux Cored Arc Welding (FCAW) process on weld joint no: SEG3020E-010 [Deck Panel diaphragm plate X4856K of DP3175A to block out bottom plate sub assembly SA3416C, CJP weld at PP128.3]. The welder is identified as 067949 and was observed welding in 2G position. ZPMC QC was identified as Mr. Zhu Lin. The welding variables recorded by this QC appeared to comply with WPS: B-T-2232-ESAB. Attached photograph provide additional details.

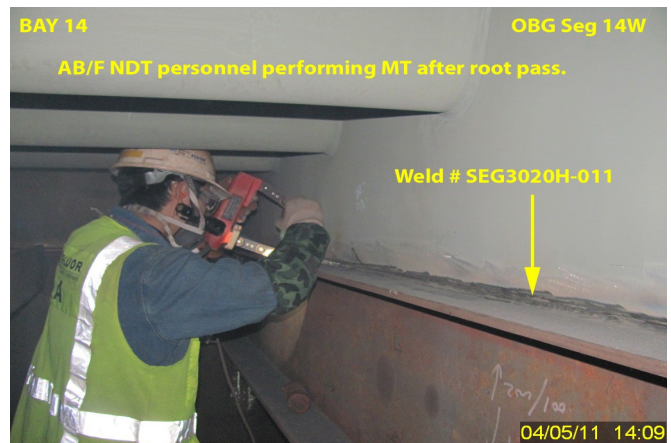
During random in process visual inspection this QA Inspector observed that AB/F NDT personnel Mr. Lin Ming was performing Magnetic Particle Testing (MT) after root pass of weld joint SEG3020H-011 joining deck panel diaphragm plate X4879C of DP3172A/DP3173A to flange of FB3332A at PP127.5. Attached photograph provide additional details.
